BLACKWELL MINE DAM

Missouri Inventory No. 30709

Phase I Inspection Report

Woodward-Clyde Consultants

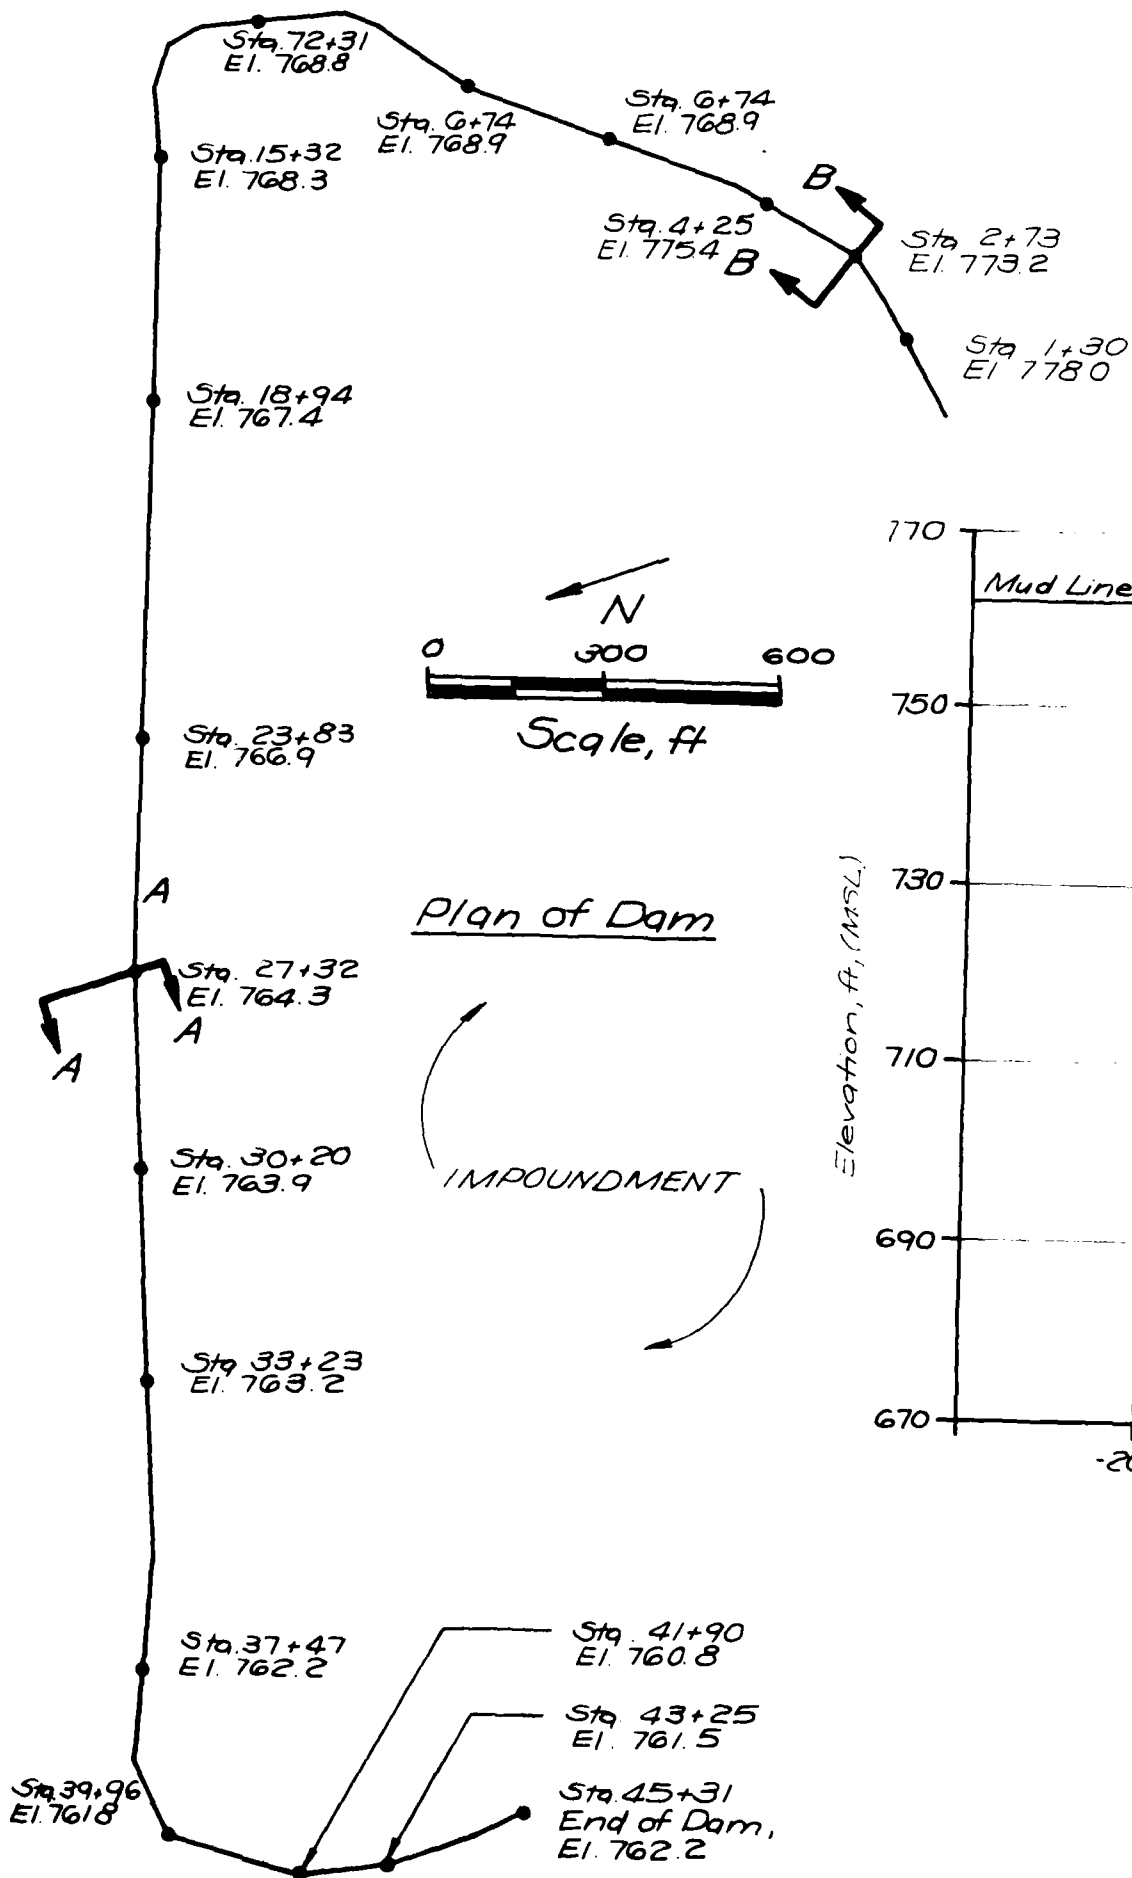
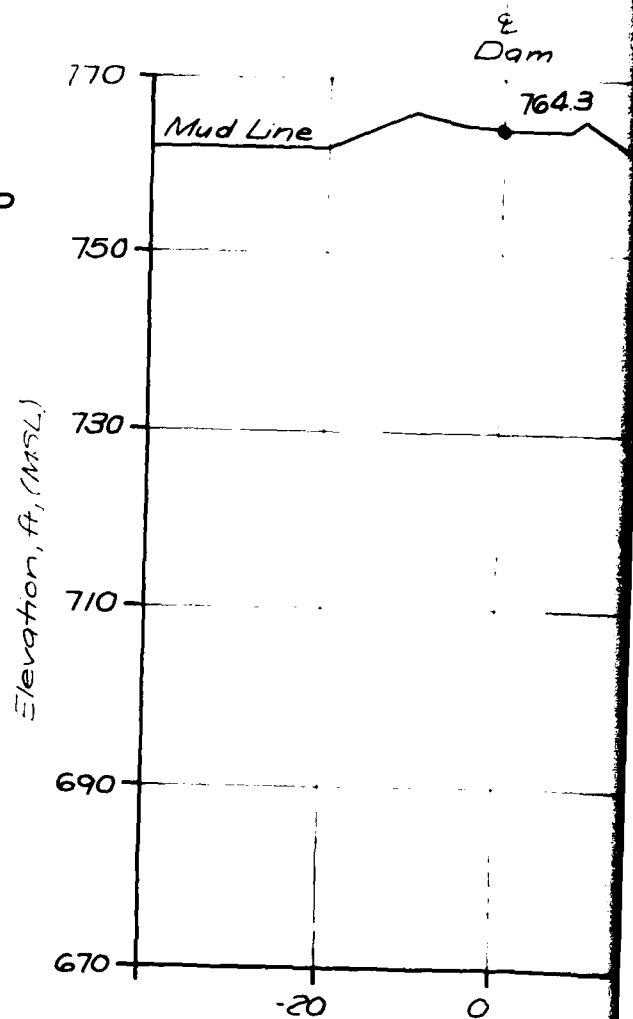
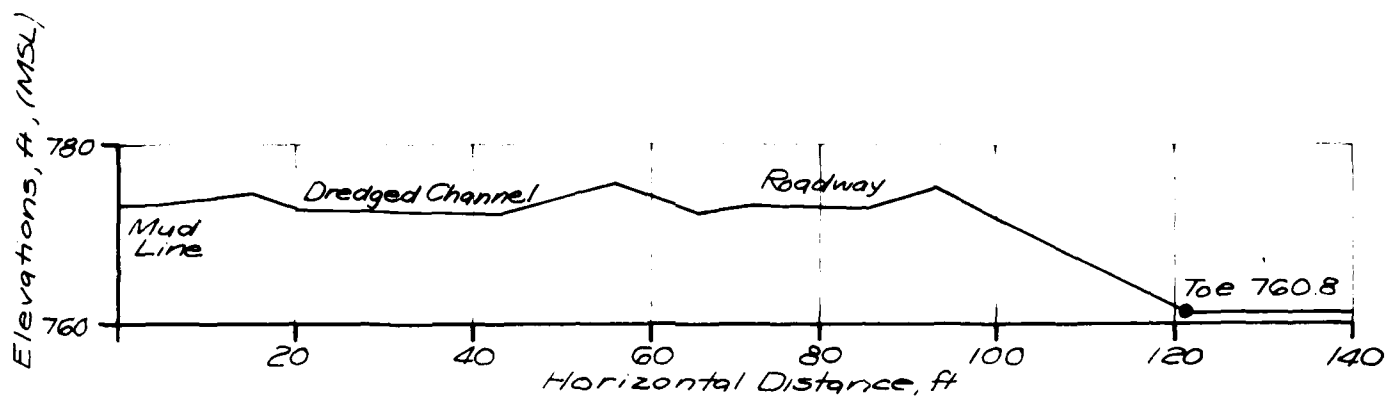
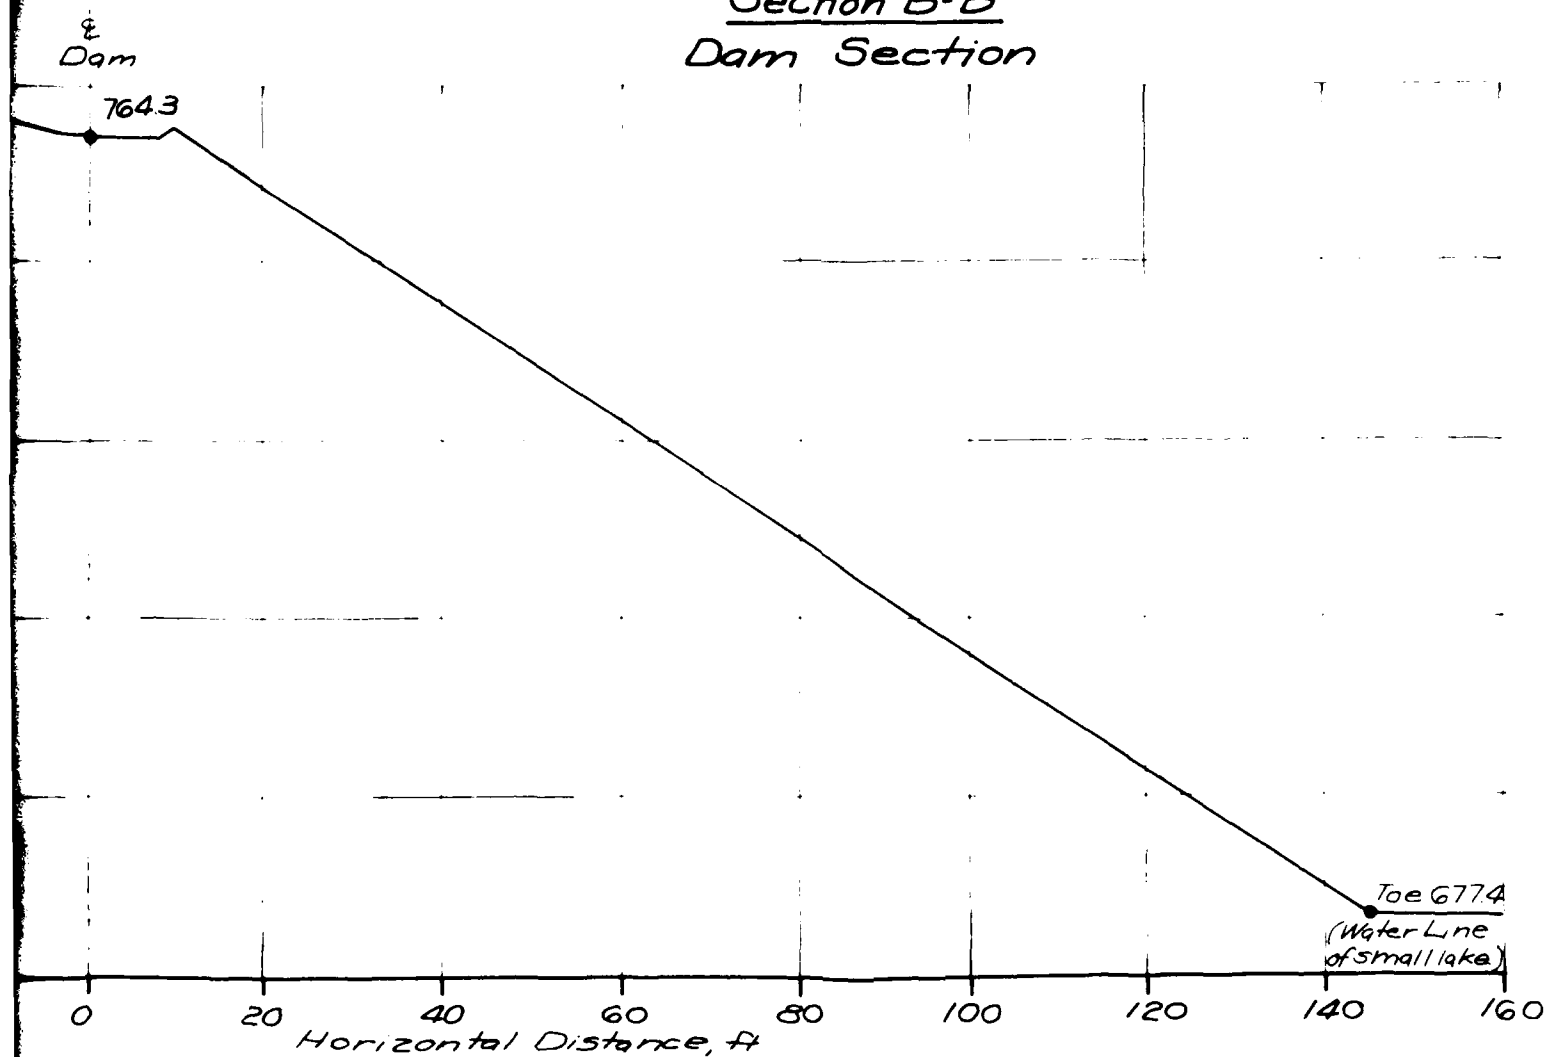
PLAN AND SECTIONS OF DAM

Section B-B
Dam Section

Section A-A
Maximum Dam Section

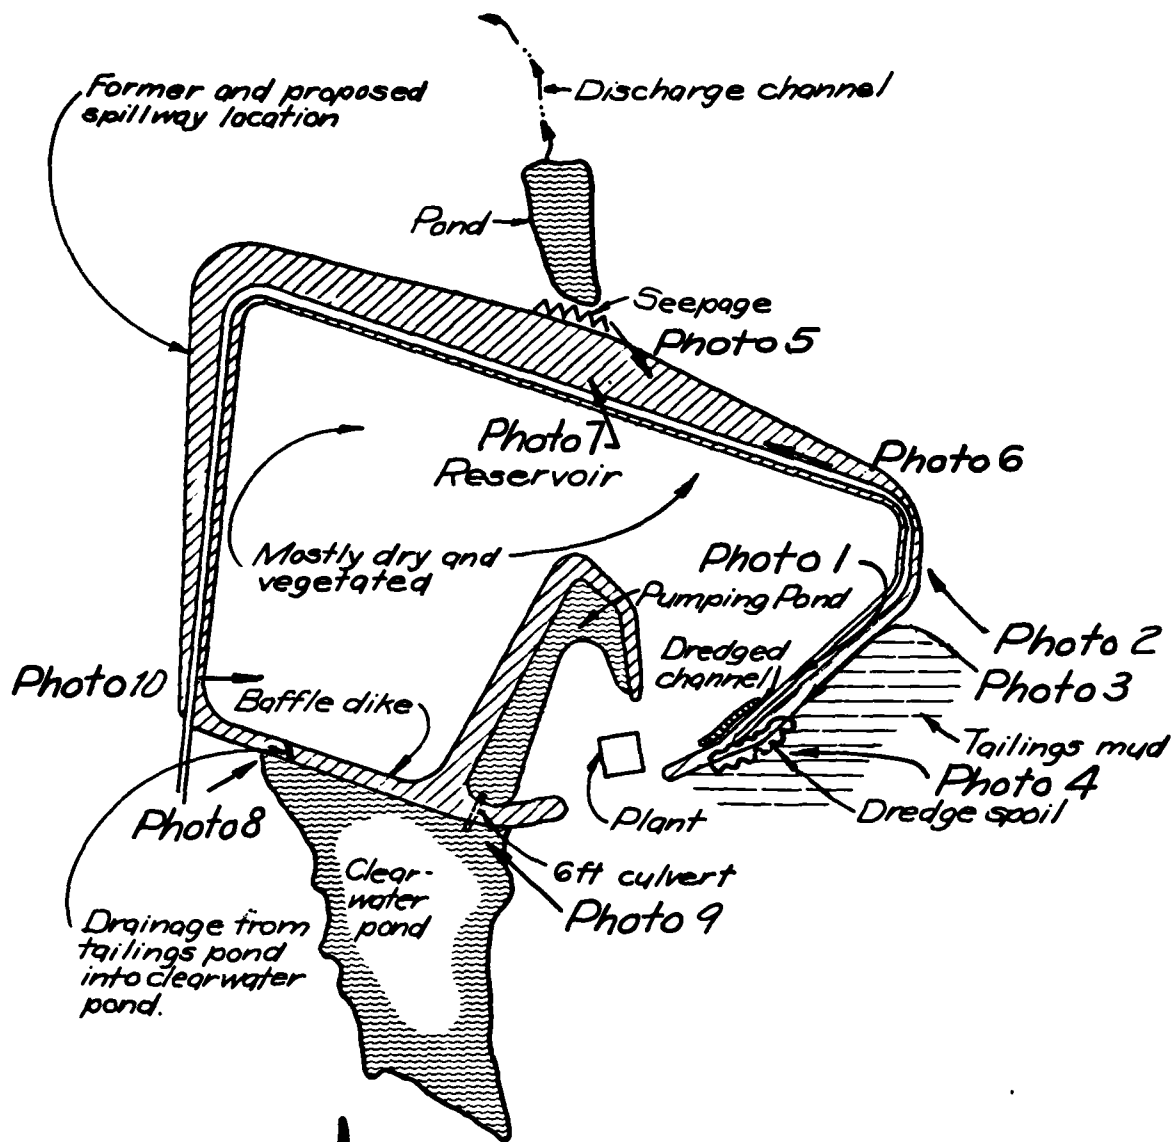
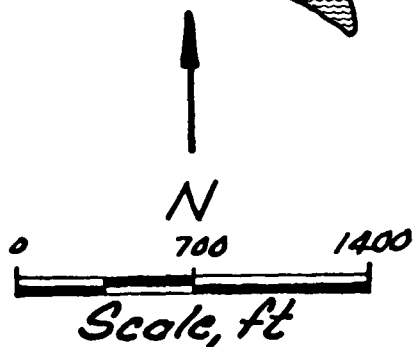
PHOTO LOCATION SKETCH	
BLACKWELL MINE DAM	
MO 30709	Fig. A-1

Along the east margin of the embankment, dredging has been done to maintain a channel deep enough to prevent overflow of the mill discharge water (Photo 1). East of and outside the embankment in this area, tailings mud has been deposited in excess of 3 ft deep (Fig A1, Appendix A; Photo 2). This
